WELDING INSPECTION REPORT

Resident Engineer: Siegenthaler, Peter **Report No:** WIR-021006 Address: 333 Burma Road **Date Inspected:** 26-Feb-2011

Project Name: SAS Superstructure **OSM Arrival Time:** 700 **OSM Departure Time:** 1900 **Prime Contractor:** American Bridge/Fluor Enterprises, a JV

34-0006 **Bridge No: Component:** OBG

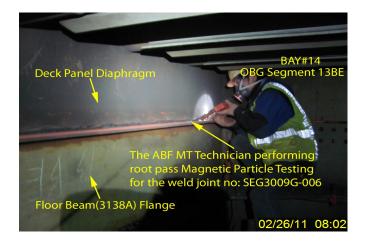
FCAW in the 2G position for the OBG Segment 13BE Deck panel diaphragm to Floor beam flange. The weld joint was designated as: SEG3009J-005. The welder is identified as #206623. ZPMC QC is identified as Mr. Zhong Guo Hui. The welding variables recorded by QC appear to comply with WPS-B-T-2232-ESAB. Please see the attached picture.
